OAKLAND INTERNATIONAL AIRPORT

Terminal 1 Security Checkpoint Building Renovation and Retrofit

By Jamison Curry, S.E., Peter Revelli, S.E., and Marko Schotanus, S.E., Ph.D.

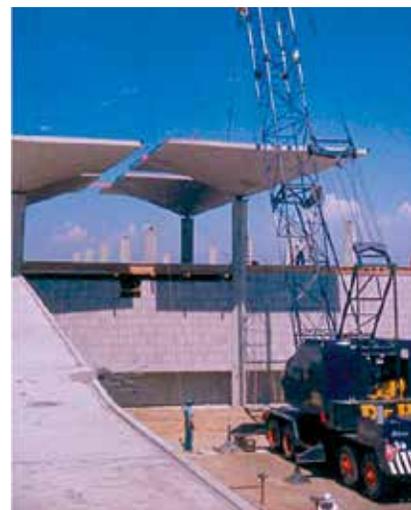
Figure 1. Original construction. Courtesy of Port of Oakland.

The building that is addressed by the seismic retrofit project presented herein functions as a security checkpoint and Port of Oakland offices. It is one of the original four structures and consists of a two-story, above-grade building over a crawl space. The building has plan dimensions of approximately 238 feet by 238 feet. Forty-eight concrete columns, at 34-feet on-center each way, support a normal weight concrete flat slab at the first floor, a lightweight concrete waffle slab at the second floor, and weakly interconnected lightweight precast concrete shells at the roof (Figure 1).

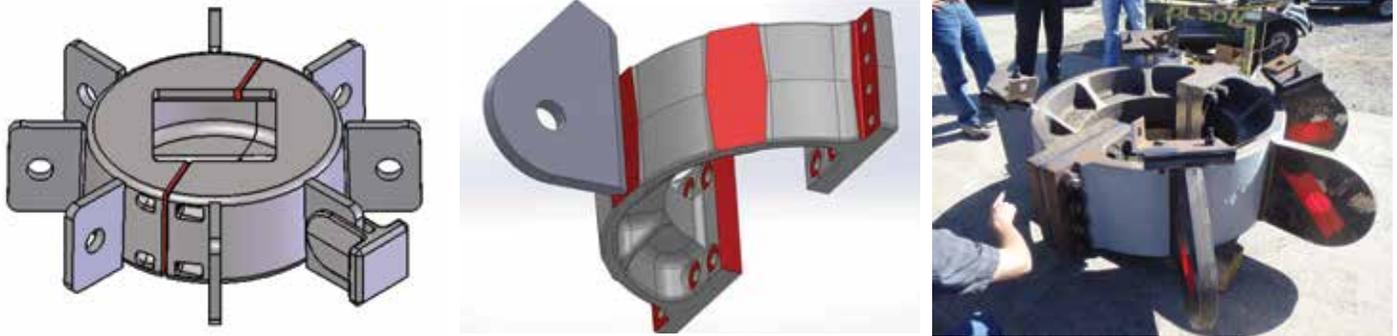
Figure 2. Various design configurations of the cast collar; actual casting on the right.

A key constraint imposed on the project team was that the security checkpoint located in this building needed to remain operational throughout construction to avoid impacts to the traveling public. From a structural perspective, the primary challenge involved the connection of the new truss members at the top of the existing columns. This connection took on many shapes during design to meet the varying demands of strength, constructability, and aesthetics. The original connection of the existing roof shells to the columns resulted in a highly congested, reinforced concrete section at the top of the columns. In addition, roof drainage was routed down each column. To avoid drilling through the column, early concepts for the connection considered a built-up section of steel plates to form a square collar around the column. This approach resulted in a considerable volume of weld material at collar corners. Making these welds in the field would have been very costly and time consuming. As an alternative, a steel casting was explored with Pacific Steel Casting of Berkeley, California. A cross section was developed iteratively in consultation with the

architect, contractor, and the foundry that responded to structural requirements, aesthetics, constructability, and production schedules. The collar consisted of two identical halves that are joined around the column in the field, resulting in a total of 96 castings for 48 connection nodes. Welded gusset plates were added to the cast collars for different configurations of brace connections (Figure 2). In collaboration with the contractor, it was decided that welding the cast collar halves together would add complexity in the field, and so the design was further modified to allow field bolting. A C-shaped cross section was revised to a T-shaped one with stiffening ribs at locations where gussets for horizontal truss members could be placed. The T-shape provided better access for bolt installation. This change also facilitated the casting operation since molten metal flows into the pattern (mold) and cools in a more controllable way. Using cast steel became the preferred alternative after mock-ups in the existing structure showed that the shape of the casting could be integrated into the project in an aesthetically pleasing manner. R+C performed a finite-element stress analysis of the casting to determine an acceptable structural configuration. The material chosen for the casting was ASTM 958, Grade SC8620 Class 80/50. This material has properties compatible with ASTM A572 Grade 50, specified for the gusset plates, and ASTM A500, Grade B, specified for the horizontal truss members.

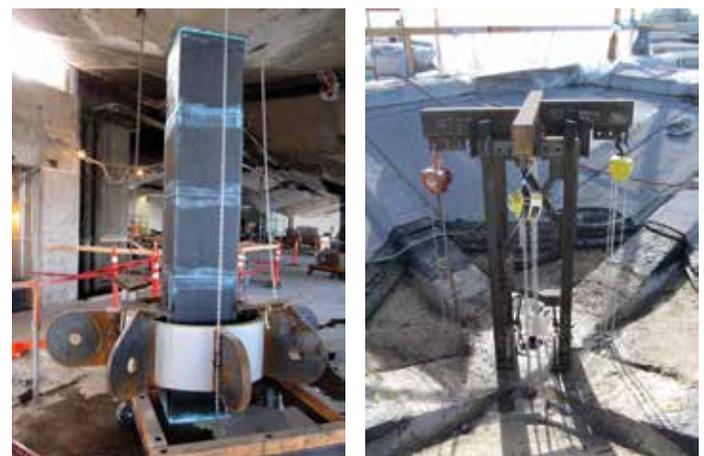
Figure 3. Olson's lifting rig – to the left is a casting being lifted into place; the rig is on the right. Note the top of the roof ribs.

Olson Steel's concept for the erection of the cast collars was to place the two halves around columns in the field on the floor level below the roof, bolt them together, and finally lift them into place. Each collar was supported from four existing roof shell ribs using a through-bolted bearing connection. Given that each collar weighed about 3 tons, this was no mean feat. Olson mocked up an assembly process in their yard using two forklifts, but this proved too difficult to achieve a safe, vertical lift of the collar. Olsen then devised a custom-made chain-hoist which allowed the collars to be picked at four points and reliably lifted to the top of the column (*Figure 3, page 27*). The collars were bolted to the existing roof ribs and grouted in place to provide good bearing between the existing column and the collar. The bracing was then

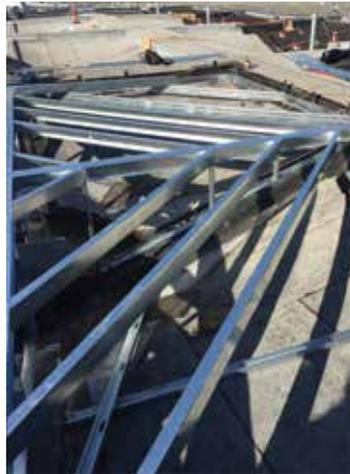
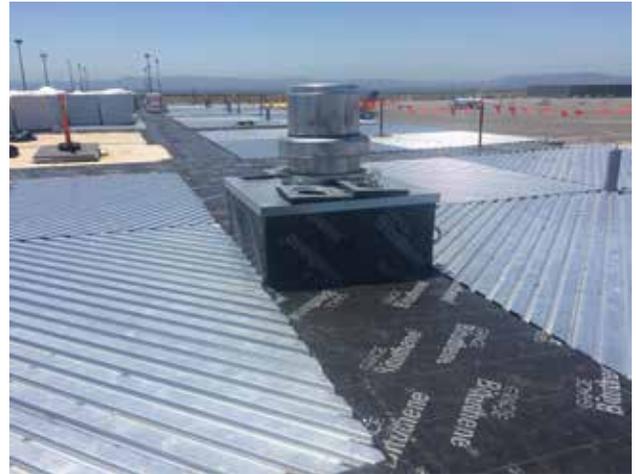
Figure 4. Shell infill – to the left is the installation of light gauge framing; it supports the metal decking shown on the right, creating a level roof plane. Courtesy of MVVA Architects.

The original 48 hyperbolic paraboloid roof shells formed individual “inverted pyramids” supported by a column, resulting in an undulating roof plane where each shell had to be independently drained. One of the project goals was to create a “flat” roof with a global drainage plane to improve the roofing system's reliability and simplify its maintenance. The original 1960 design accounted for ponding of water in each shell, and so the initial plan for the retrofit was to fill the shells with EPS and foam – within the ponding load allowance – and maintain distributed loading. When the roofing contractor advocated an alternate infill design consisting of a light gauge framing “lid” (*Figure 4*), R+C developed a detailed computer model to analyze the significantly different way in which this scheme applies loads to the shells. In-situ load testing was used to validate the analysis results.
